ESTB
SWEET KLEEN LAUNDRY
1925

Site conditions prior to EPA cleanup

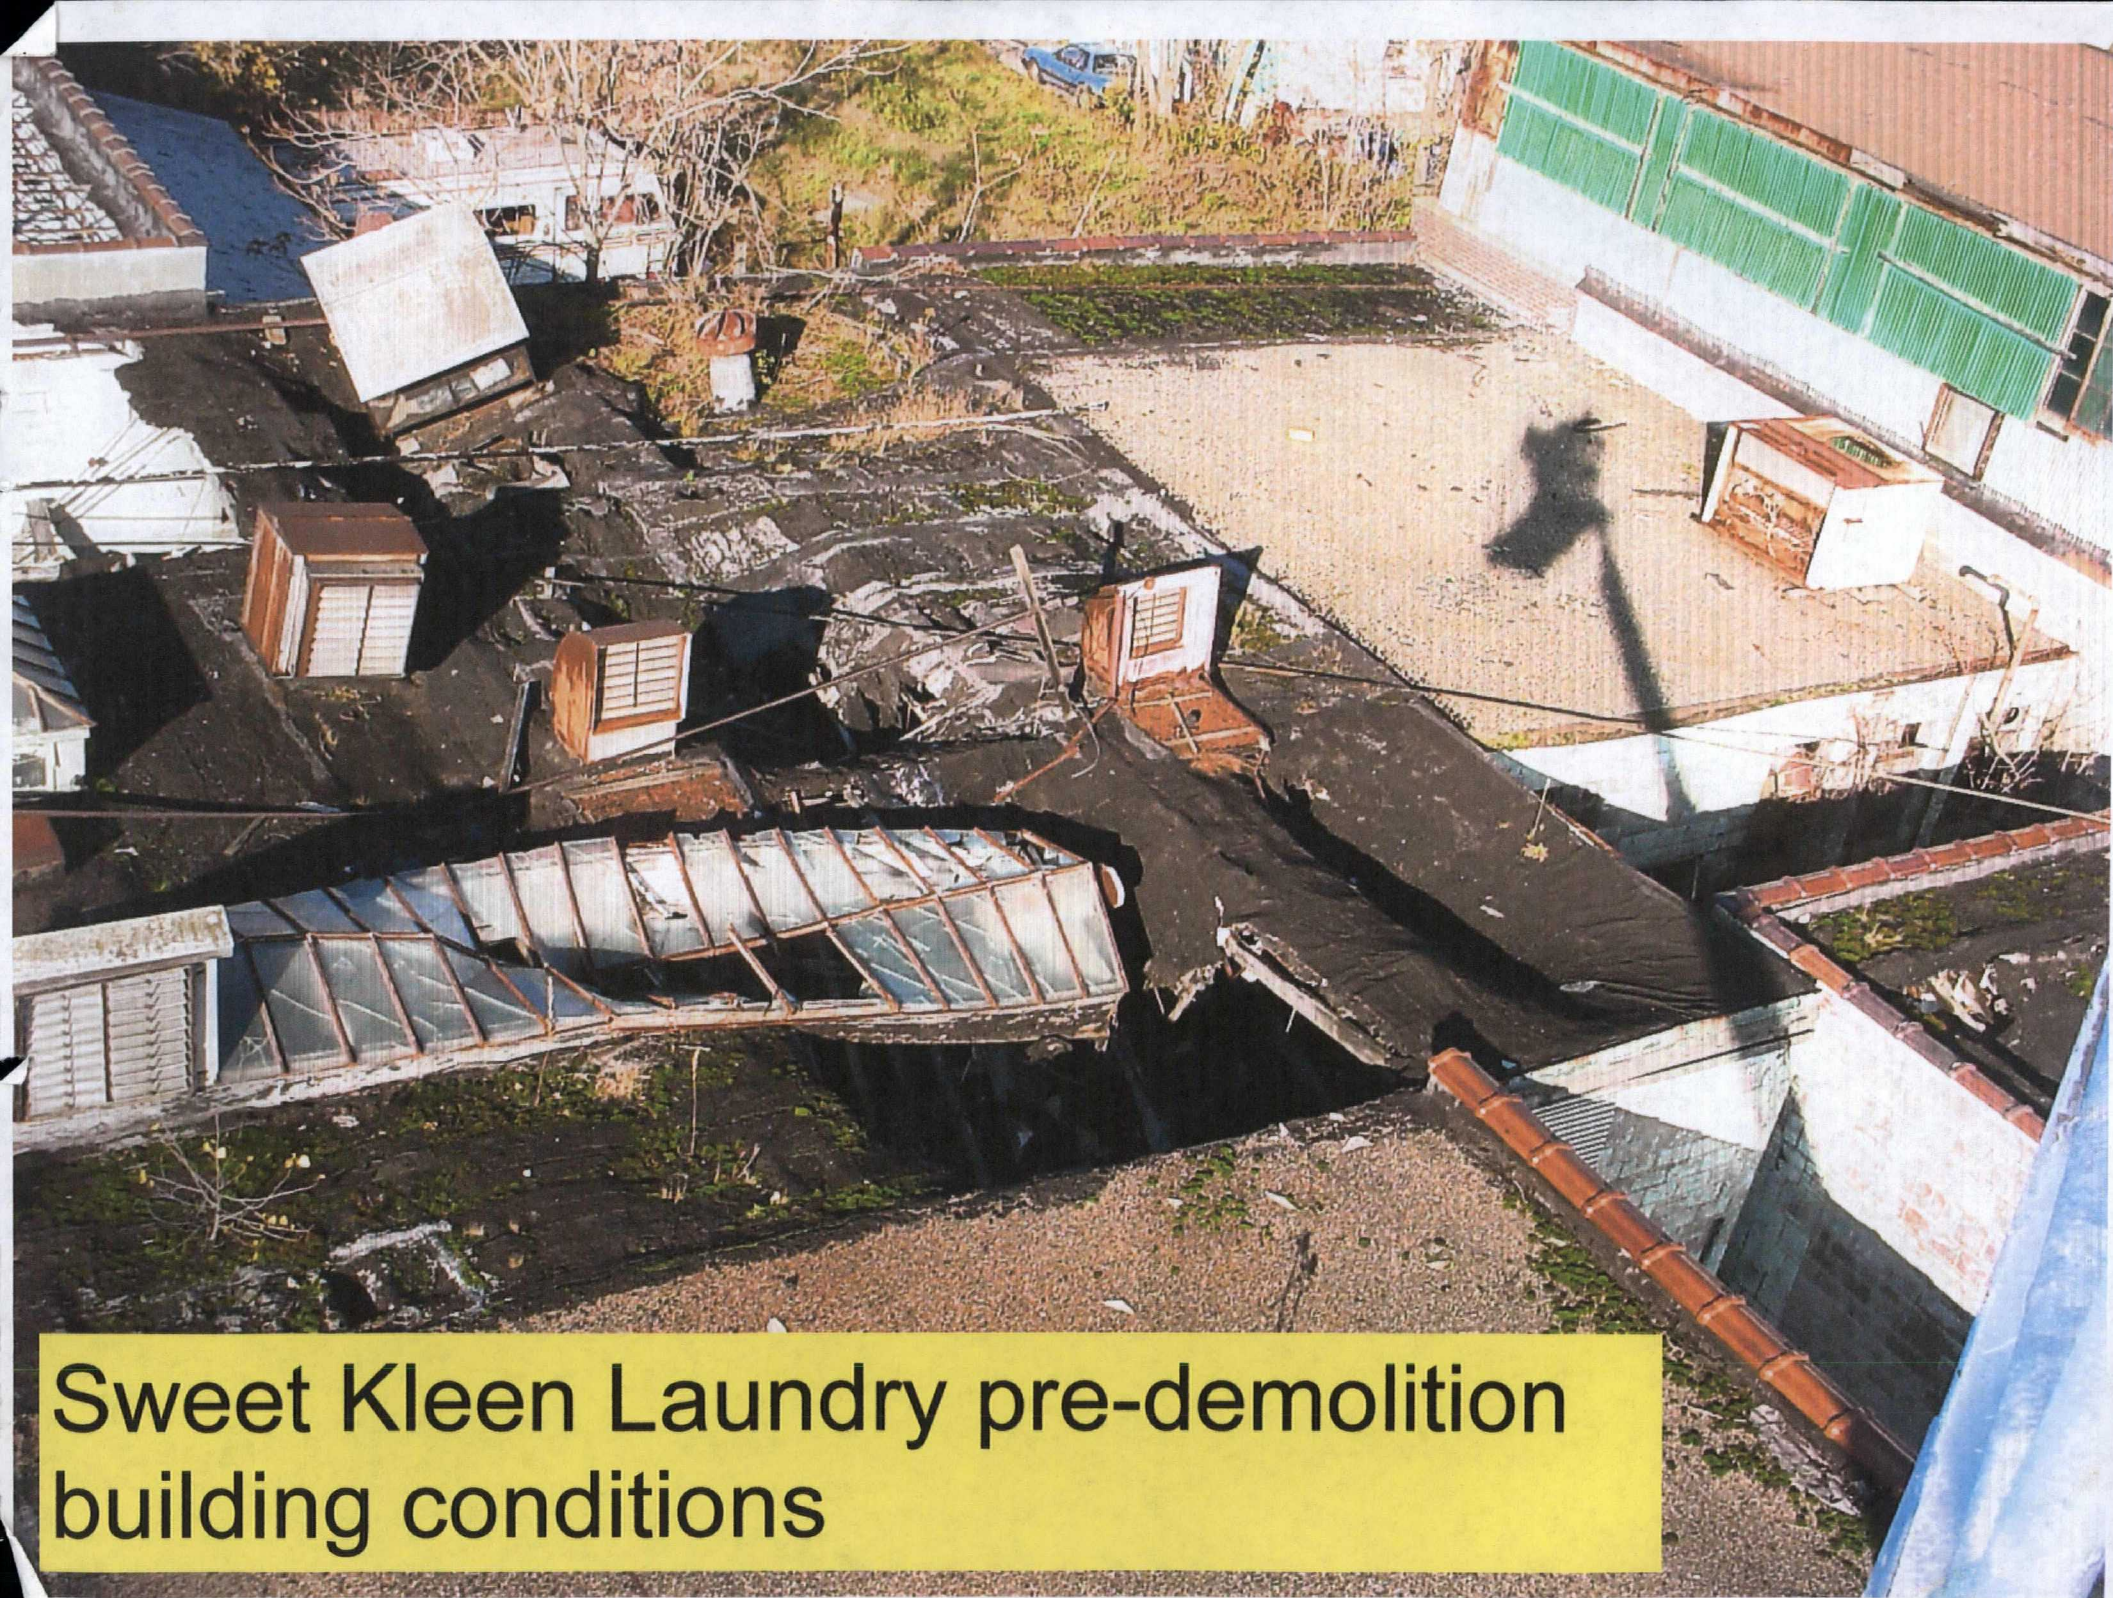
Sweet Kleen Laundry pre-demolition building conditions

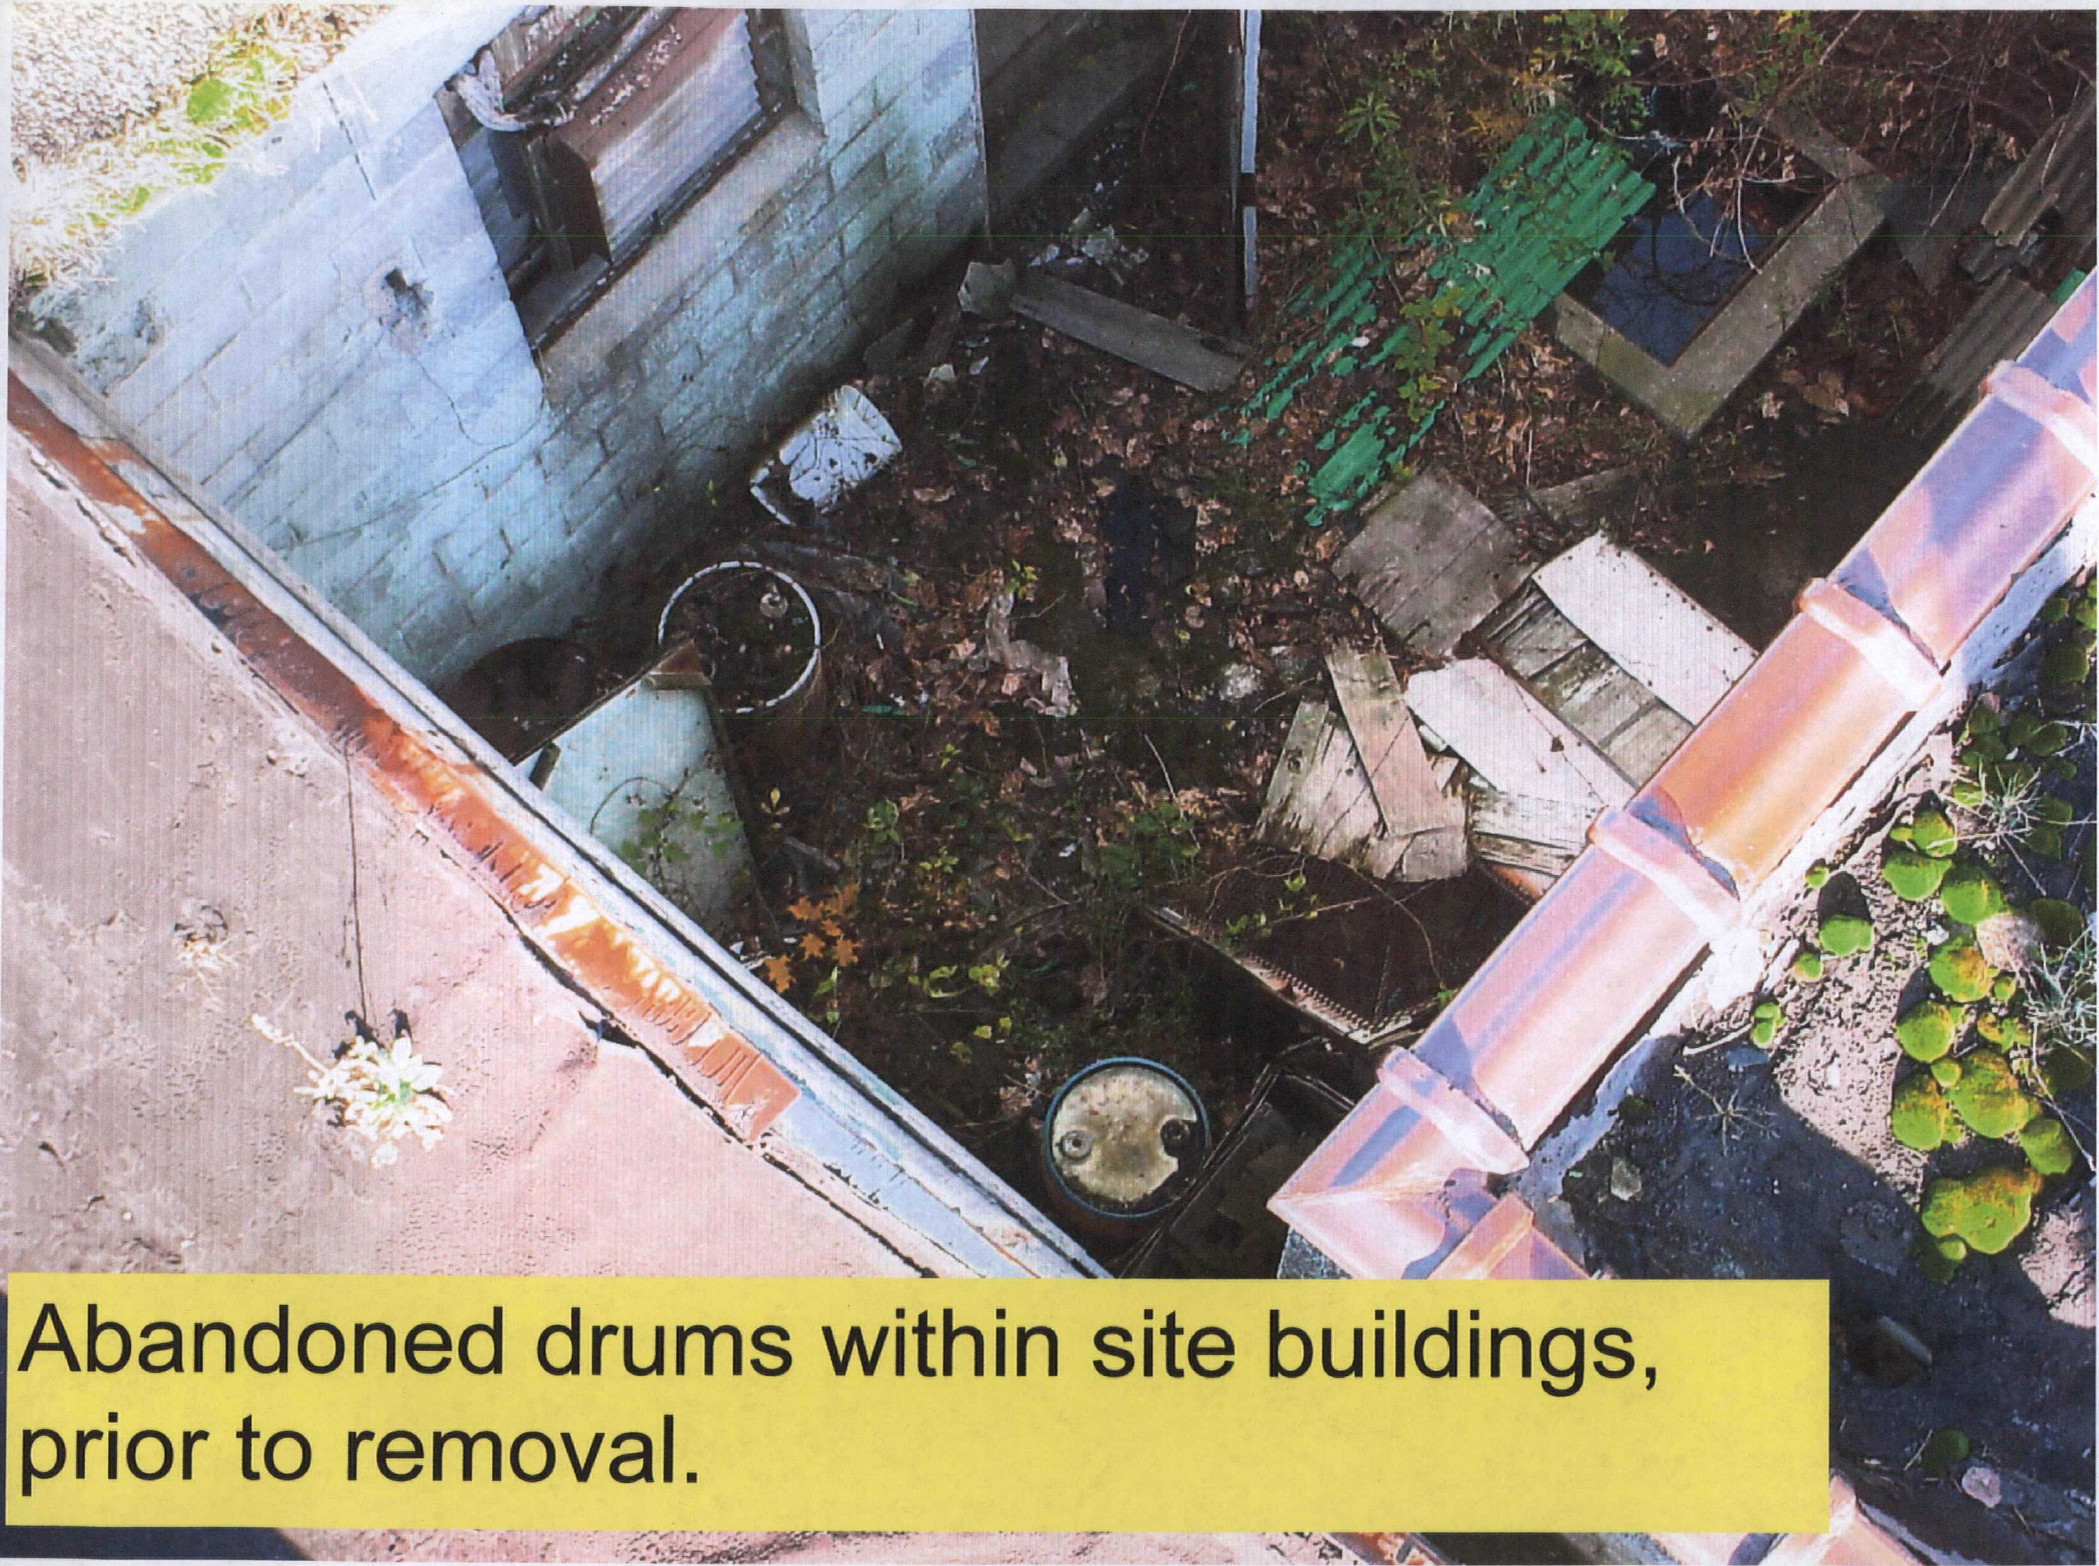
Abandoned drums within site buildings,
prior to removal.

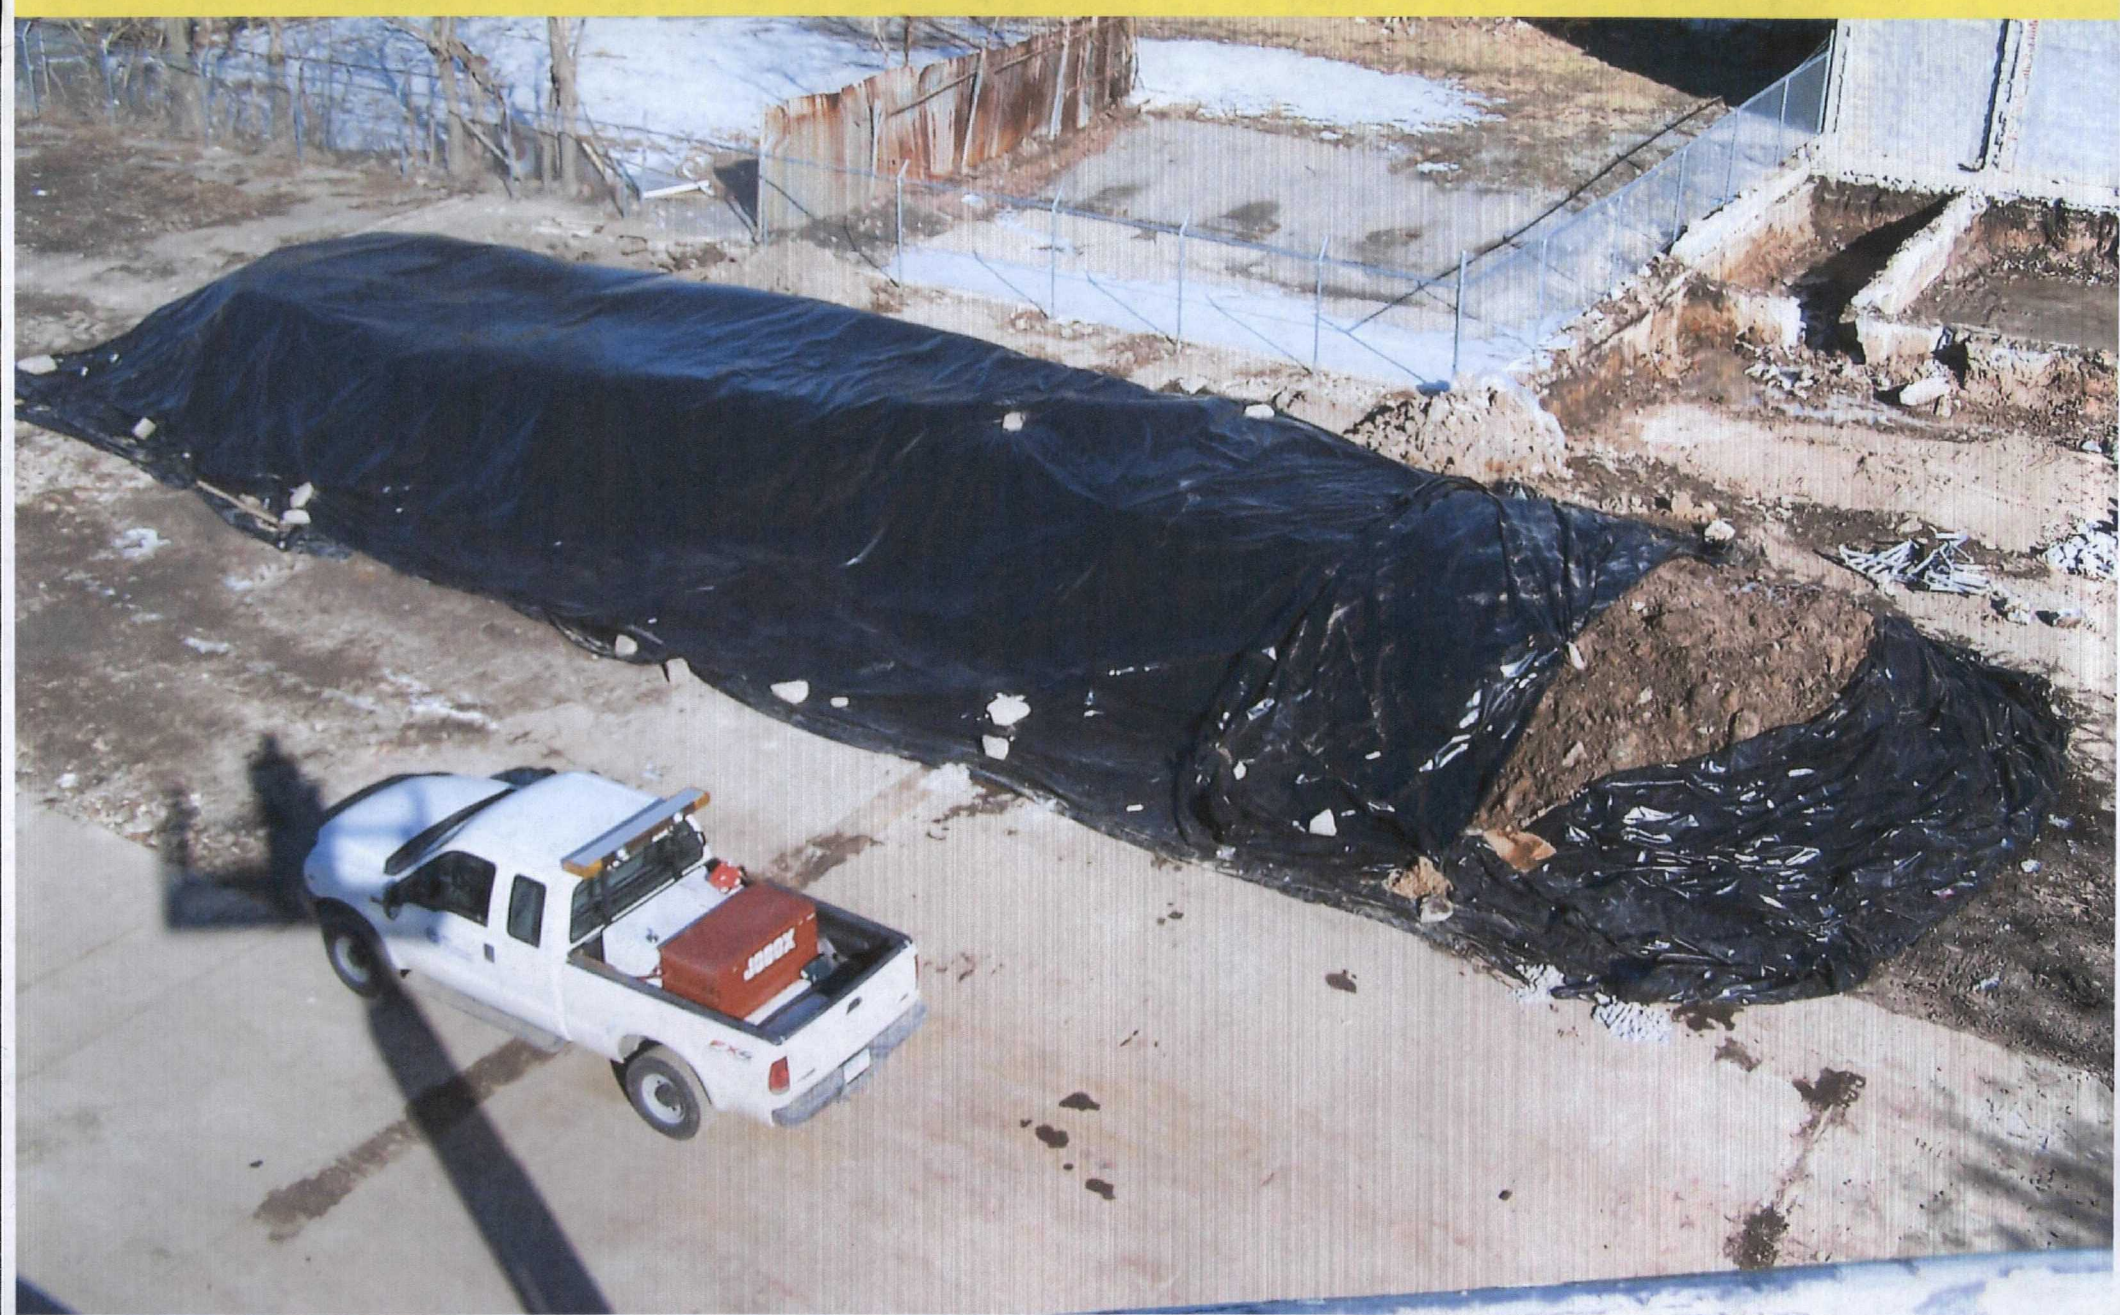
Perchloroethylene contaminated soils excavated and staged for disposal.

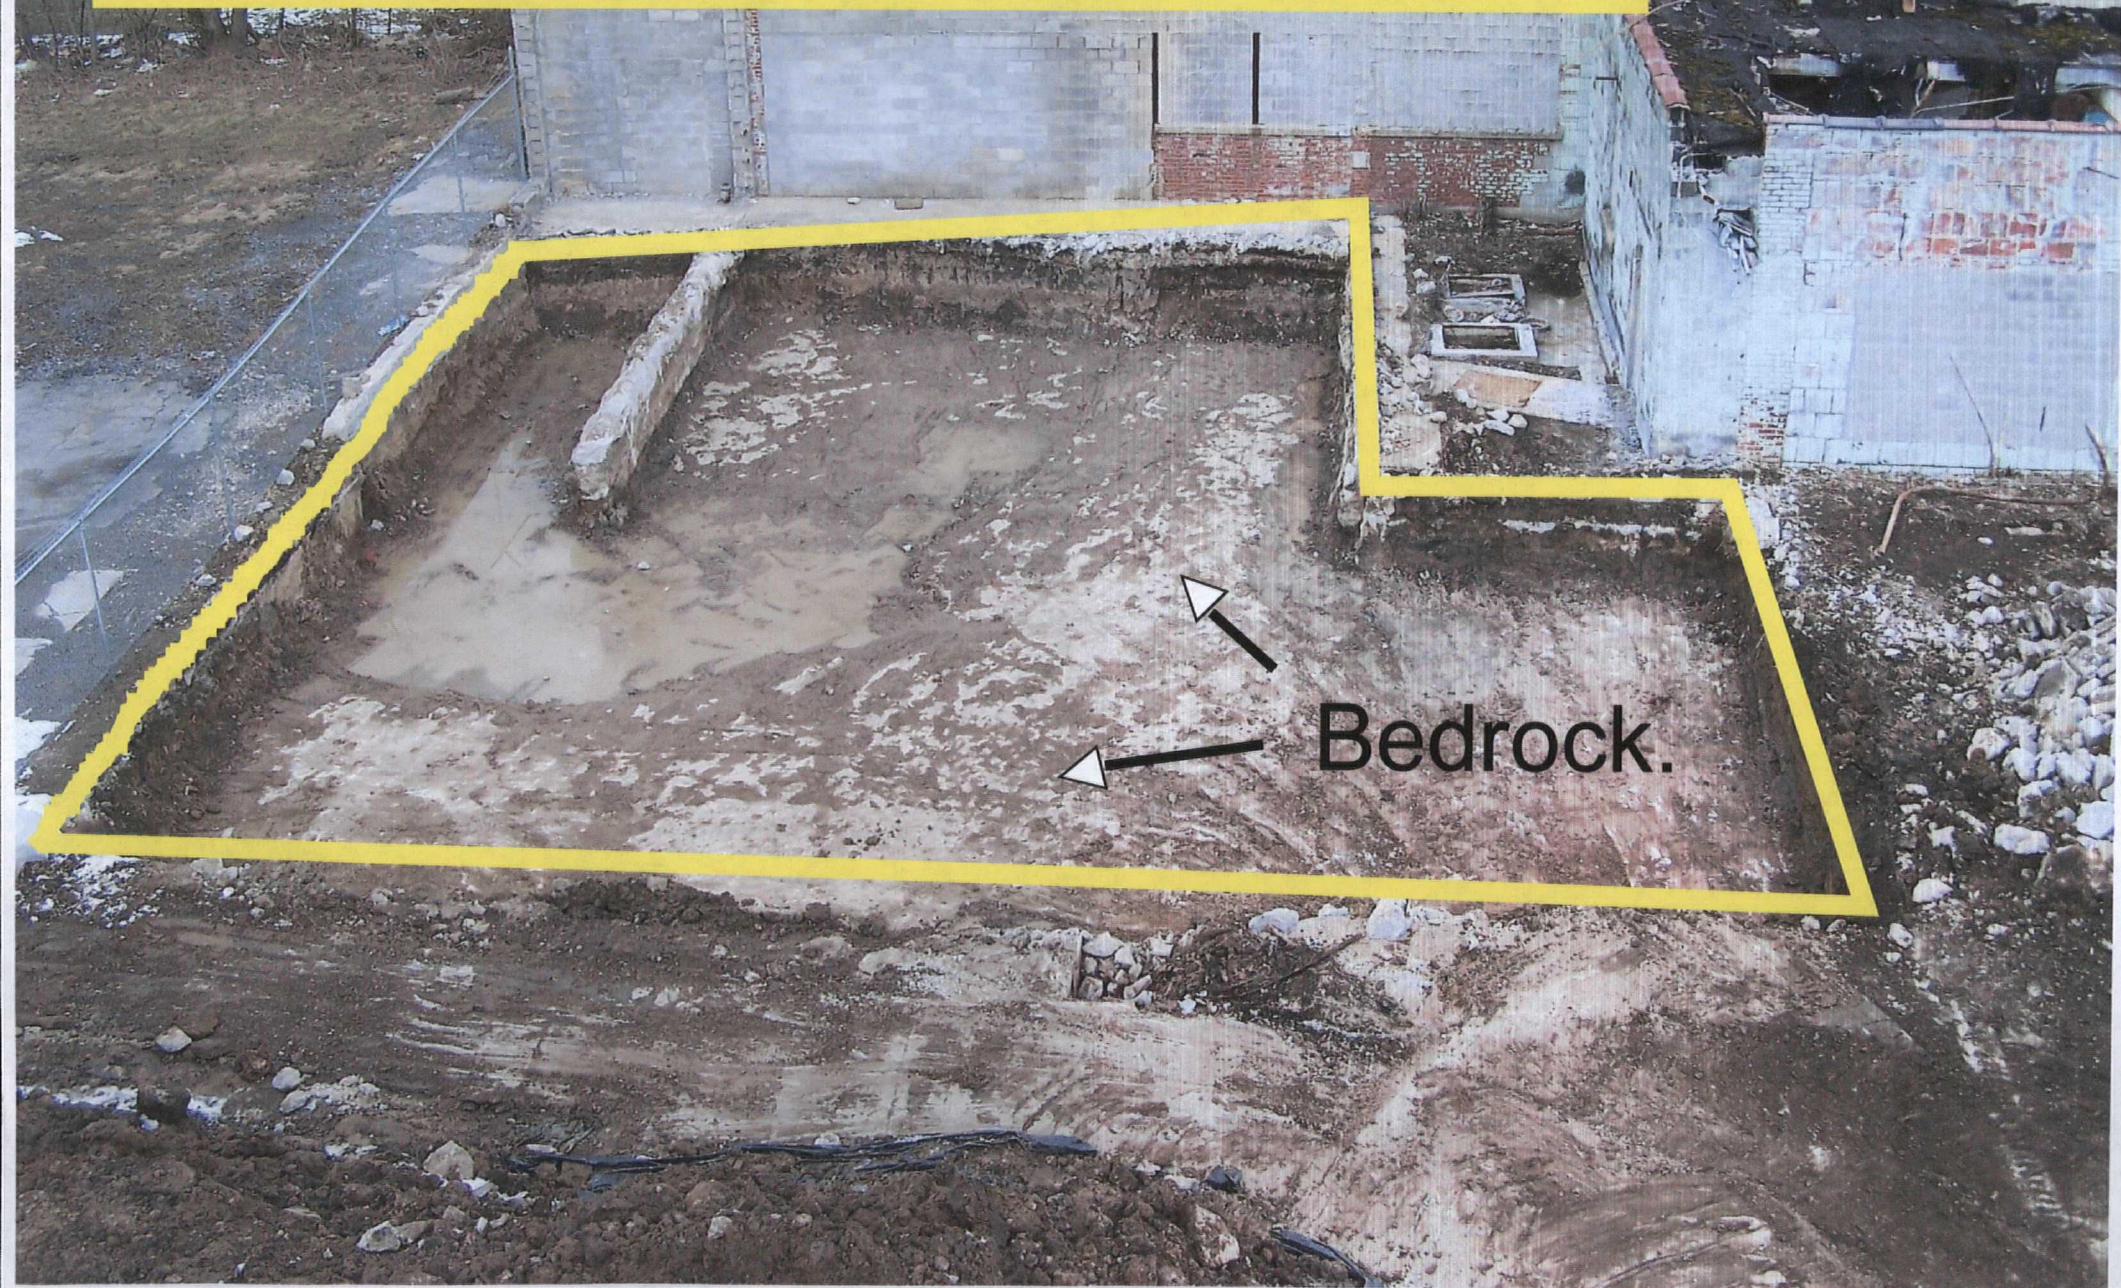
Perchloroethylene contaminated soil excavation area

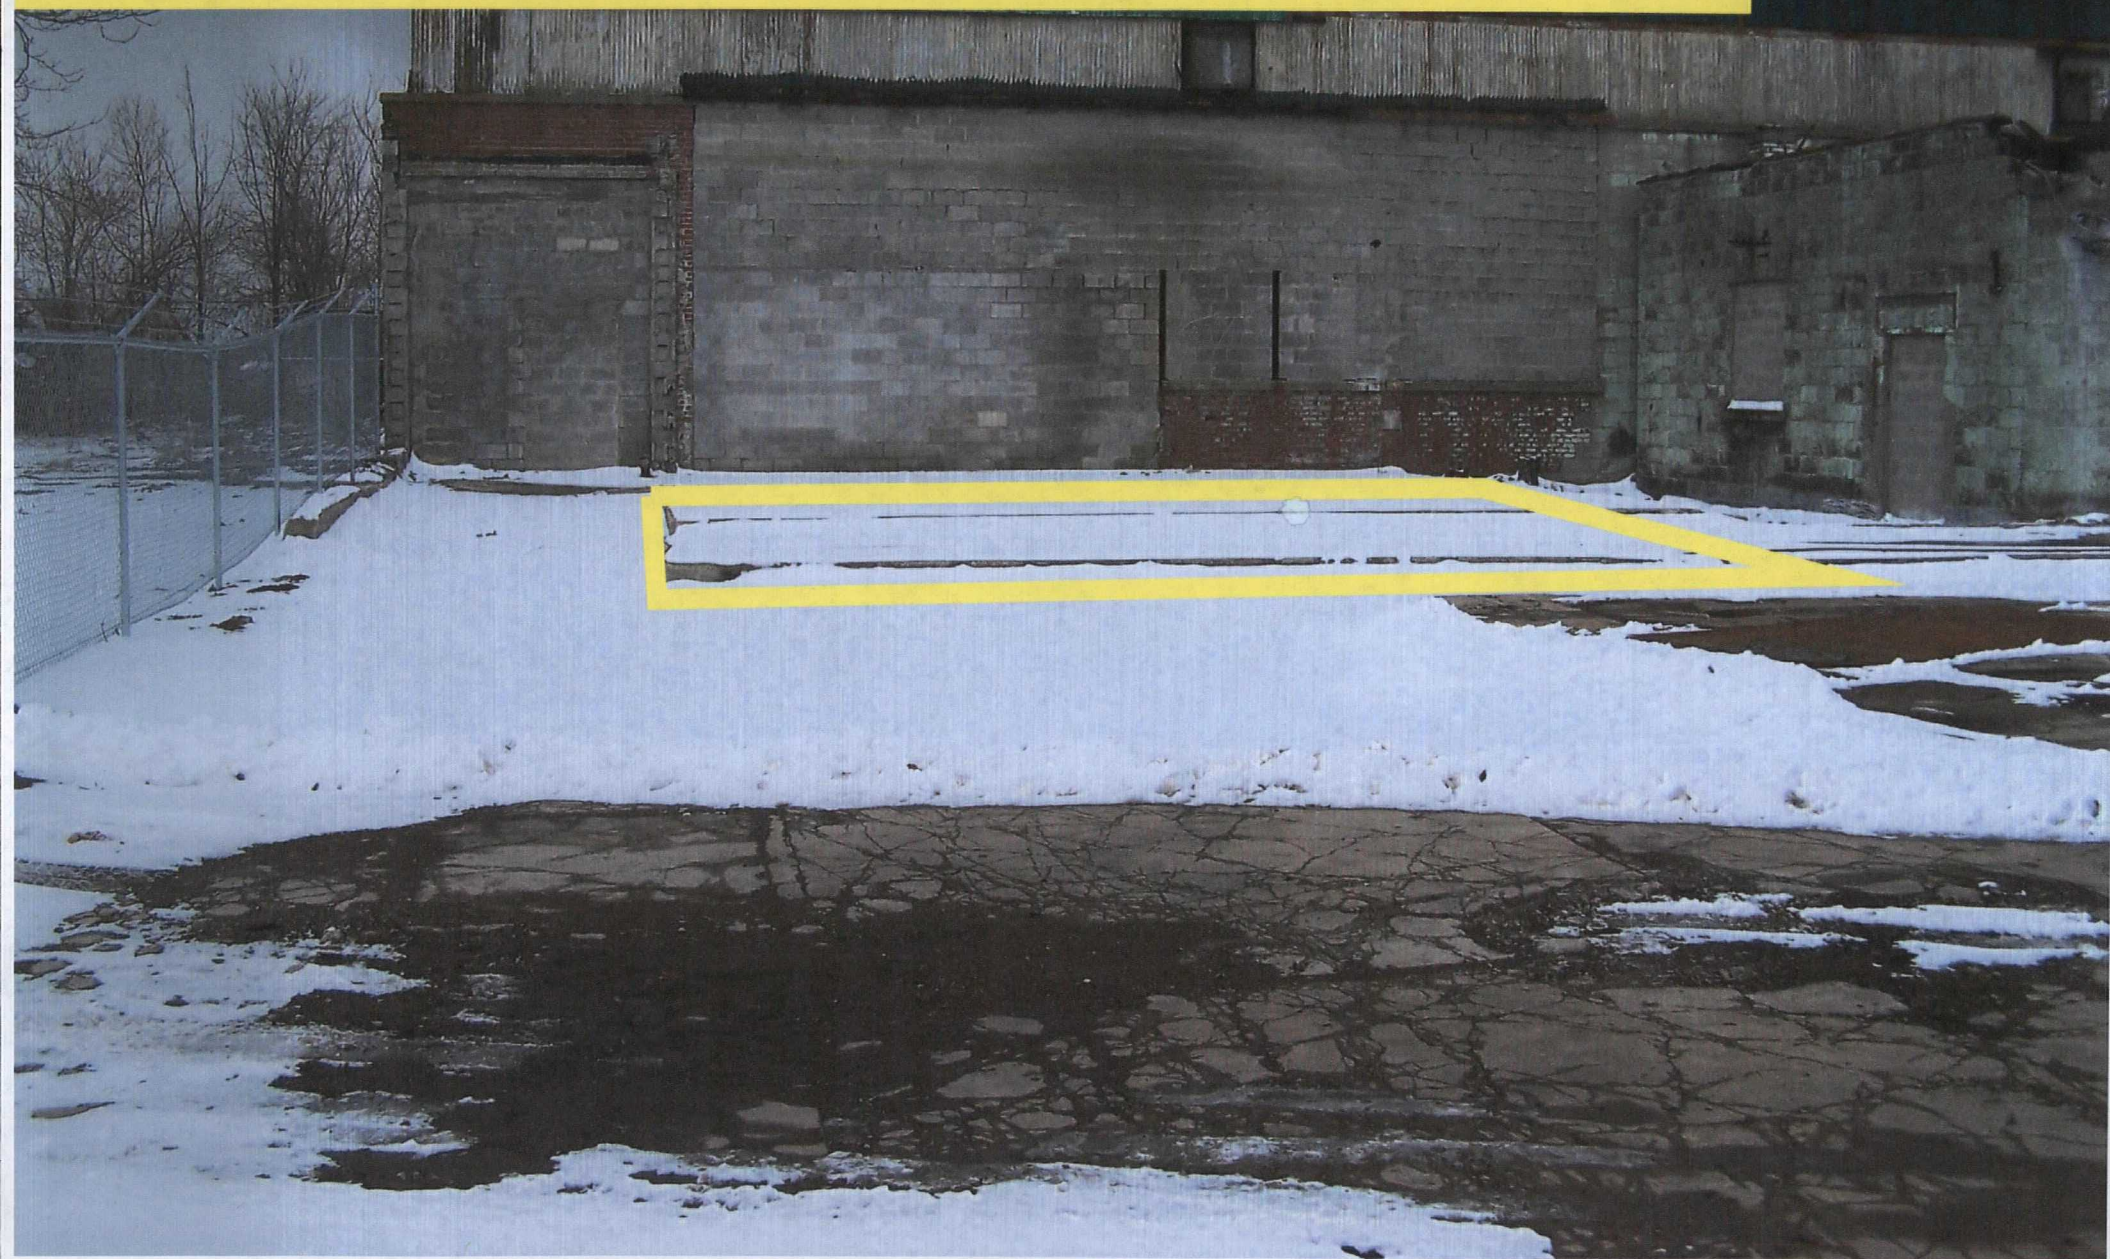
Location of perchloroethylene
contaminated soil prior to excavation.

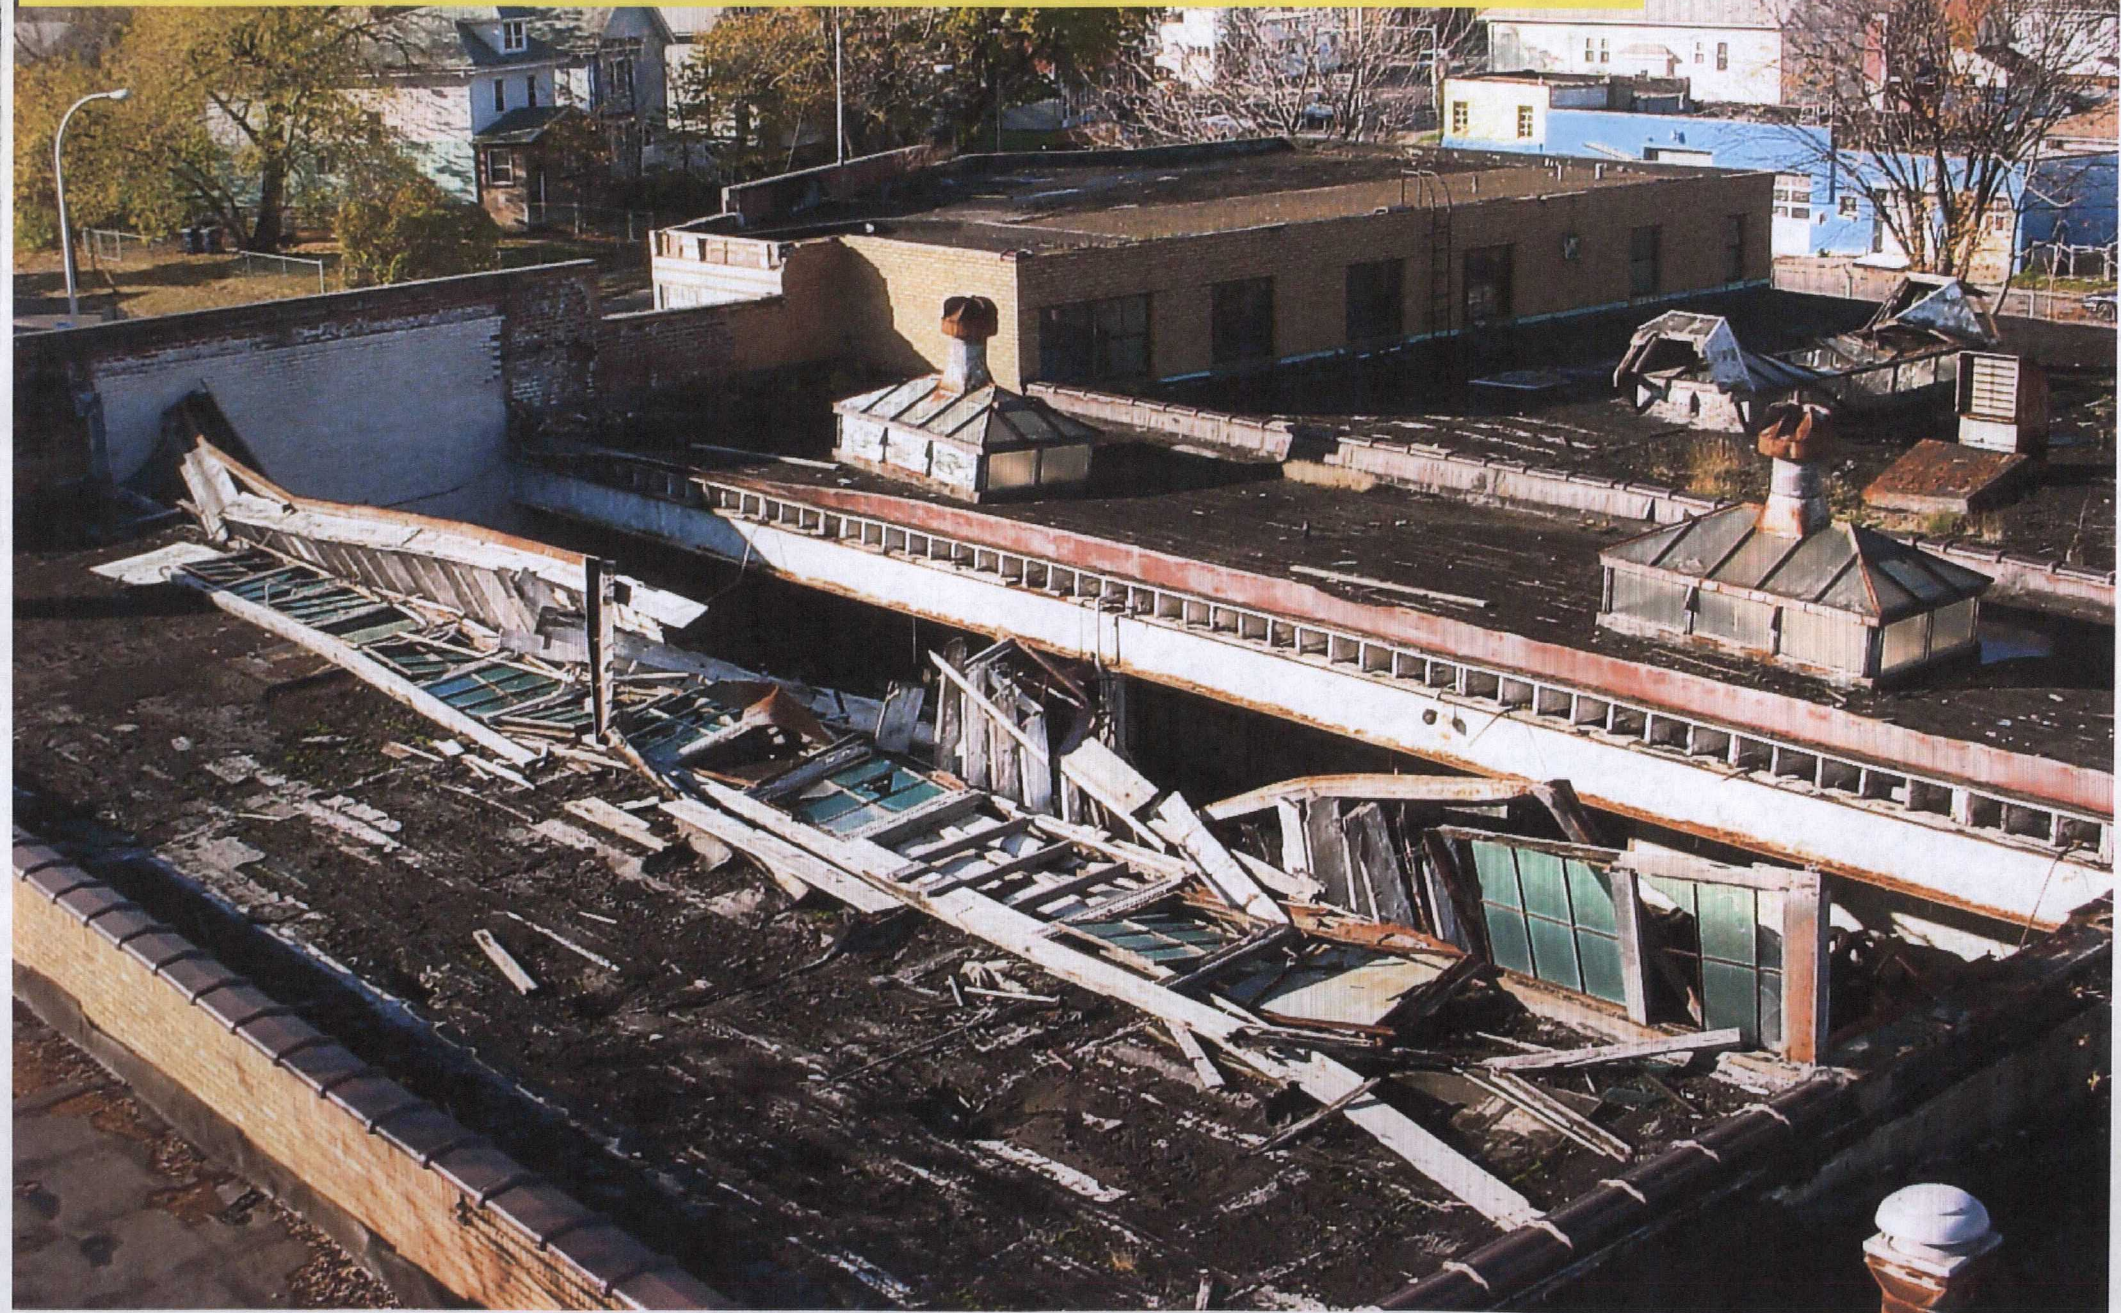
Sweet Kleen Laundry pre-demolition building conditions
